Manhole Inspection Summary

Manhole # S33AA2012MH

Location Address: **5411 PURLINGTON WAY**

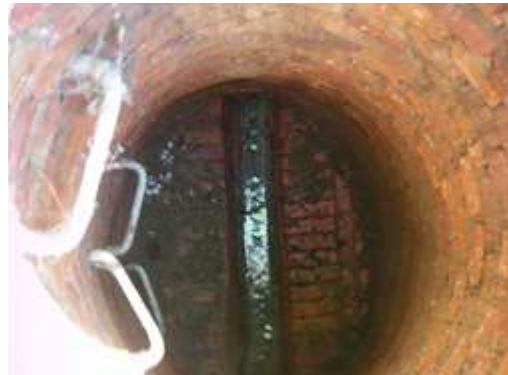
Top View

Bench debris.

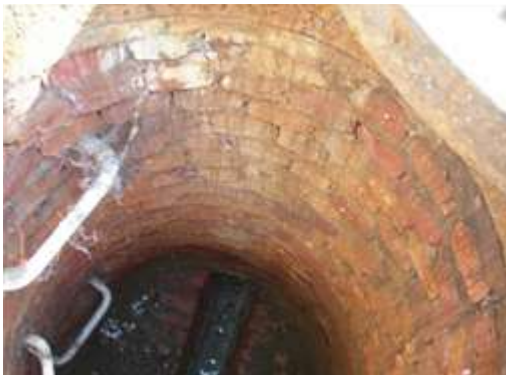
Defect

Adjustment deterioration and infiltration.
Barrel infiltration.

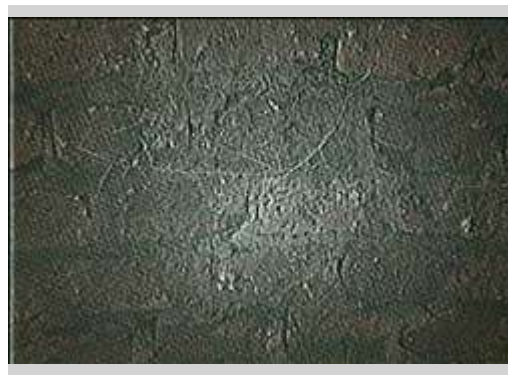
Defect

Barrel deterioration, root intrusion and
infiltration.

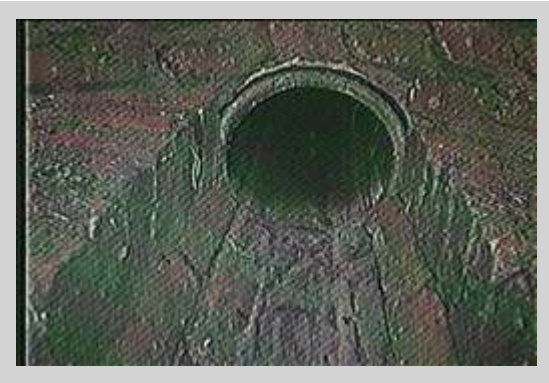
8 in. Circular Gravity Sewer Pipe Out @ 12 O'Clock

Channel deterioration.

Infiltration: **Evidence** Pipe Seal Cond: **Unknown**

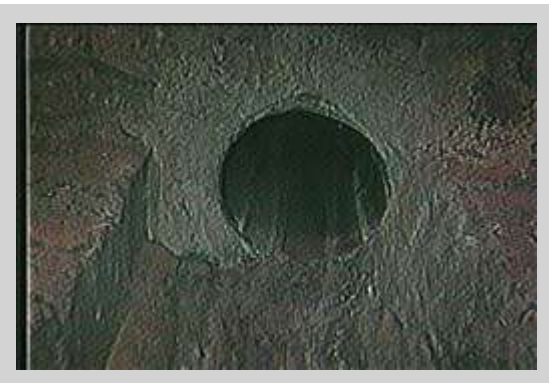
8 in. Circular Gravity Sewer Pipe In @ 6 O'Clock

Infiltration: **Evidence** Pipe Seal Cond: **Unknown**
